INDOOR AIR QUALITY ASSESSMENT

**Berkshire Family & Probate Court
44 Bankers Row
Pittsfield, Massachusetts**

Prepared by:
Massachusetts Department of Public Health
Bureau of Environmental Health Assessment
October, 1999

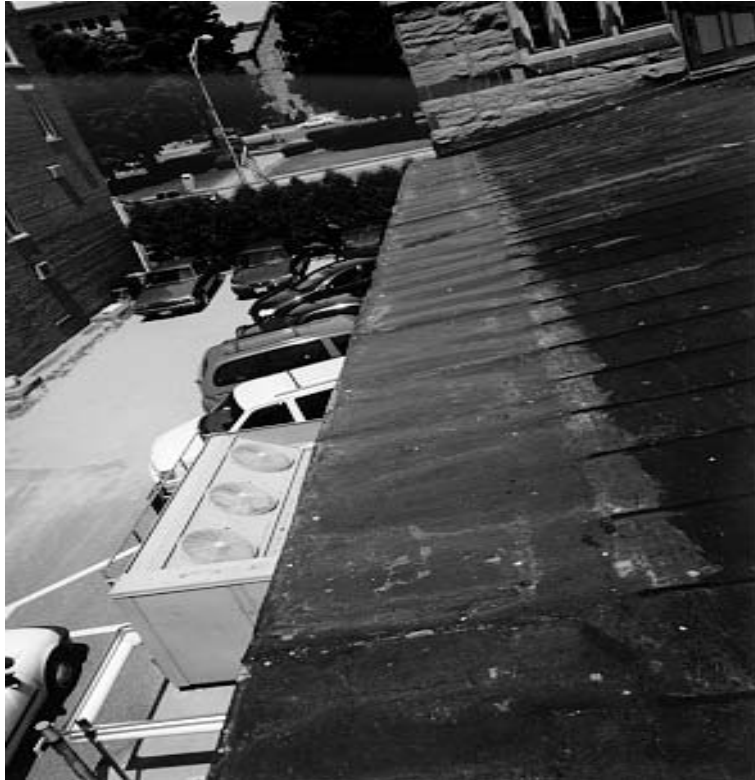
Picture 4

Enhancing water accumulation in this pit is the lack of a gutter system along the high peaked and low sloped roofs of the south section. It appears that the renovations resulted in the building's gutter system being sealed and abandoned (see Picture 11). Rainwater runs directly off the high peaked slate roof, which in turn runs directly off the low sloped roof into the pits flanking the south section. This low sloped roof also allows for the accumulation of snow that slides from the high peaked roof. Accumulation of snow can create ice dams, which can result in damage to the material of the low slope roof and enhance water penetration into the building's interior.

Low Slope Roof of South Section
Note That Roof Renovations Sealed the Built-in Gutter System on the South Wing,
Allowing Rainwater and Snow to Drop into a Pit Located at the Base of the Exterior Wall

11. In order to prevent the development of ice dams on the low slope roof, snow should be removed from these roofs as soon as practicable after snowstorms. Please note that the method to remove snow should not damage the roof material.
12. Ensure plants are equipped with drip pans. Move excessive numbers of plants from windows. Discontinue the use of paper towels on wooden windowsills to absorb excess water underneath plants. Inspect drip pans periodically, clean and disinfect with an appropriate antimicrobial as necessary.

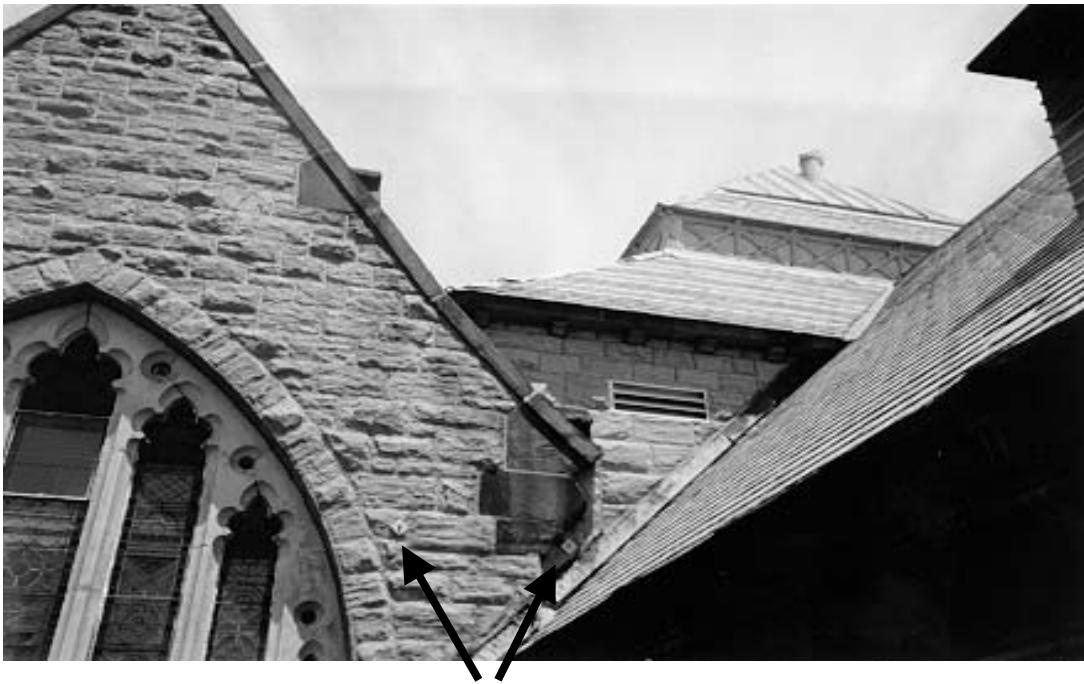
Picture 5

**Stain Glass Windows without Exterior Storm Windows,
Note Tie Back Fasteners in the Walls**

1. Examine the feasibility of providing an exterior storm window or an equivalent treatment to the exterior of the stained-glass windows to prevent water penetration. Consider consulting a restoration consultant for the best method for repairing broken sections of the stained-glass windows.
2. Examine the feasibility of restoring the original gutter and downspout system to improve water drainage from the roof.
3. Consider consulting a building engineer to examine the exterior of walls on the southwest portion of the south wall of the south section to determine the means by which water is penetrating into the interior of the building.

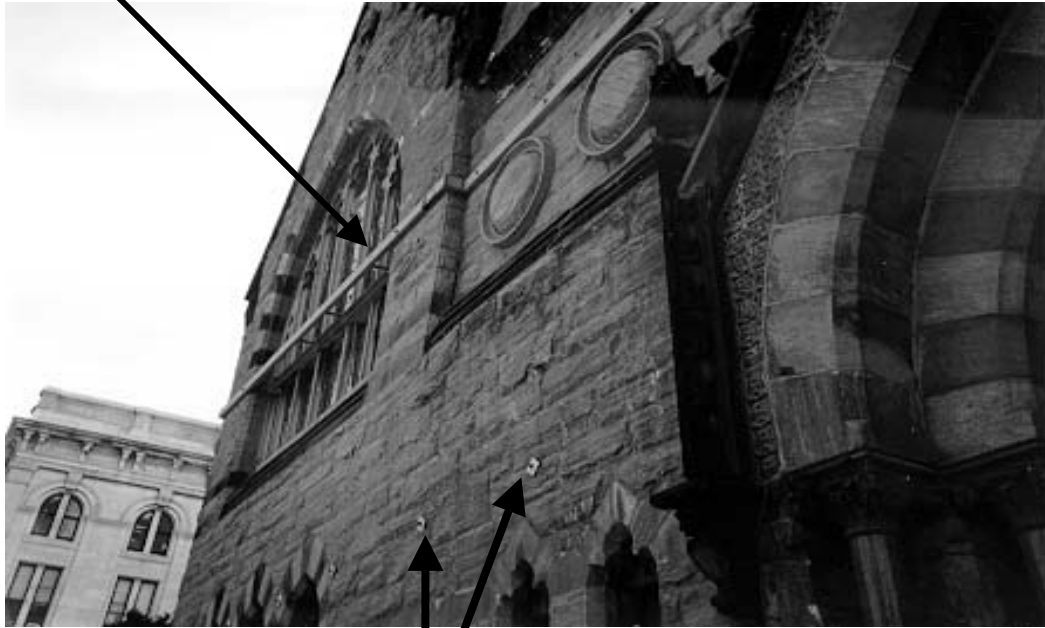
Picture 6

**Stain Glass Windows without Exterior Storm Windows,
Note Tie Back Fasteners in Walls and as Well as Exterior Steel Beam**

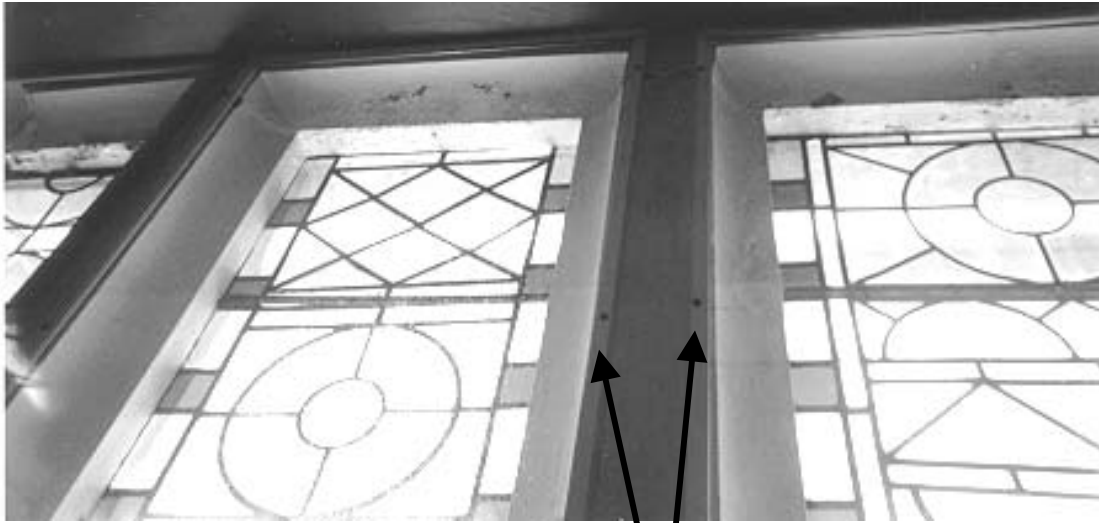
Picture 7

As noted in the background section, alterations to stabilize the exterior walls of the east, west and center sections were made with the installation of tiebacks inside and the steel support band on the exterior of the building. As part of these renovations, plexiglass was installed over the interior window frames of the stained-glass windows of the north and south walls of the east and west section. Plexiglass sheets were cut to fit over the window frames and were attached to the walls with screws (see Pictures 7 & 8).

The exterior sides of the stained-glass windows are exposed to the outdoors without similar storm window protection. Broken pieces of the stained-glass window were observed, which can readily allow water to enter into the space created and its plexiglass covering. Seals in and around the stained-glass windows appear to be leaking; resulting in water damaged plaster. The warm, moist environment between windowpanes can provide conditions conducive to microbial growth.

**Water Damaged Stain Glass Window Frames,
Note the Installation of Plexiglas over the Interior of the Window Frame(s)**

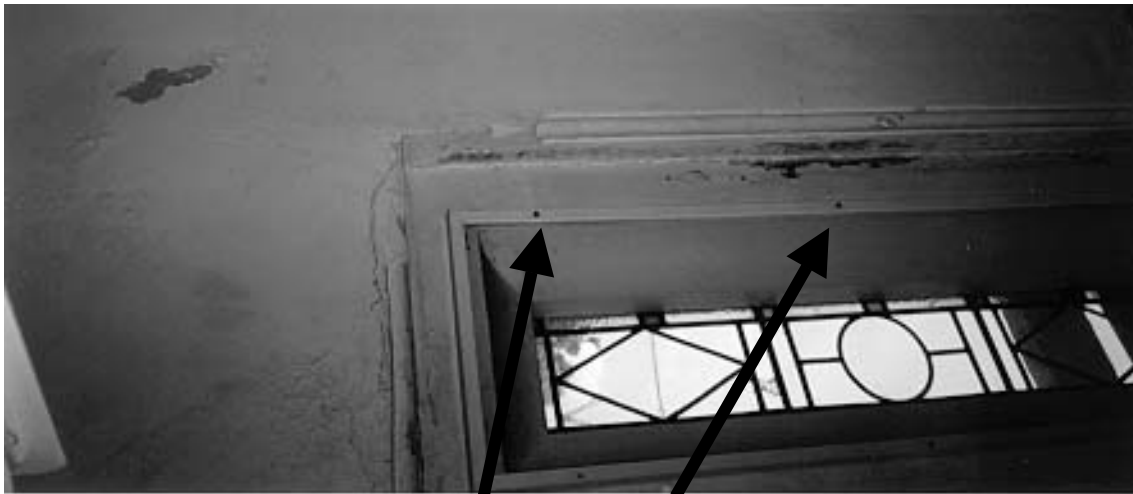
Picture 8

**Water Damaged Stain Glass Window Frames,
Note the Installation of Plexiglas over the Interior of the Window Frame(s)**

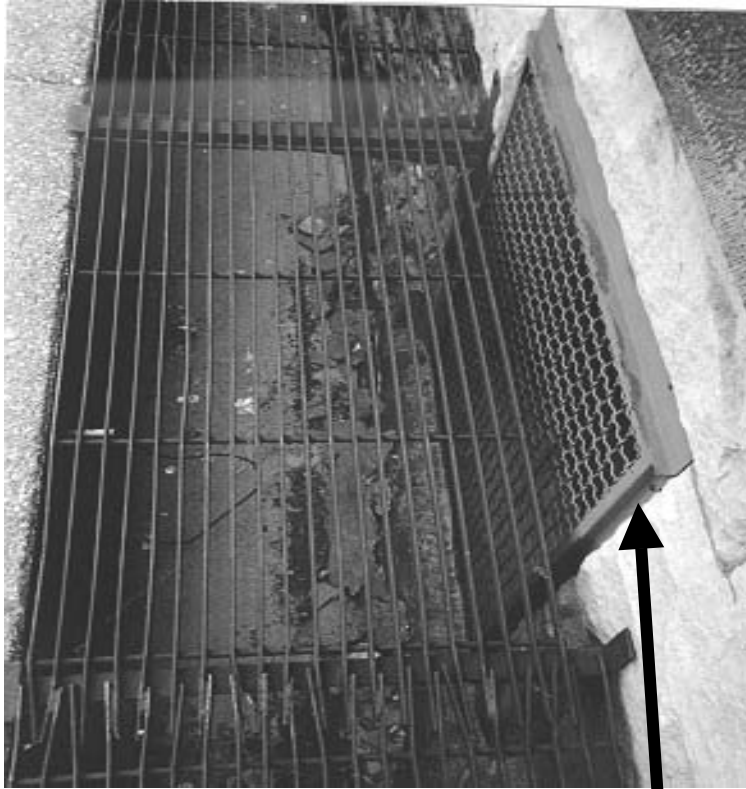
Picture 9

to the grand jury and storerooms exist in the walls of these pits (see Picture 9). Each pit appears to have a drain, which is designed to remove water and prevent flooding as well as subsequent water penetration through these basement window frames. A significant amount of debris has accumulated within these pits, which appears to partially block these drains (see Picture 10). This may result in water penetration into basement window frames. A severely bowed windowsill was found in a window of a grand jury room, which may indicate water penetration. This debris should be cleaned from drains and the area should be inspected periodically for proper drainage to avoid standing water collecting outside of ground floor windows. Standing water can become stagnant and provide an additional medium for bacterial and microbial growth.

Pit at the Base of the South Wing
Note Grate That Covers Window to Room in Basement
Note the Collection of Sand and Debris in Floor of Pit

8. Clean concrete lined pits around the south section. Ensure that the drains in the floor of these pits are clean and providing an adequate amount of drainage to prevent pooling water.

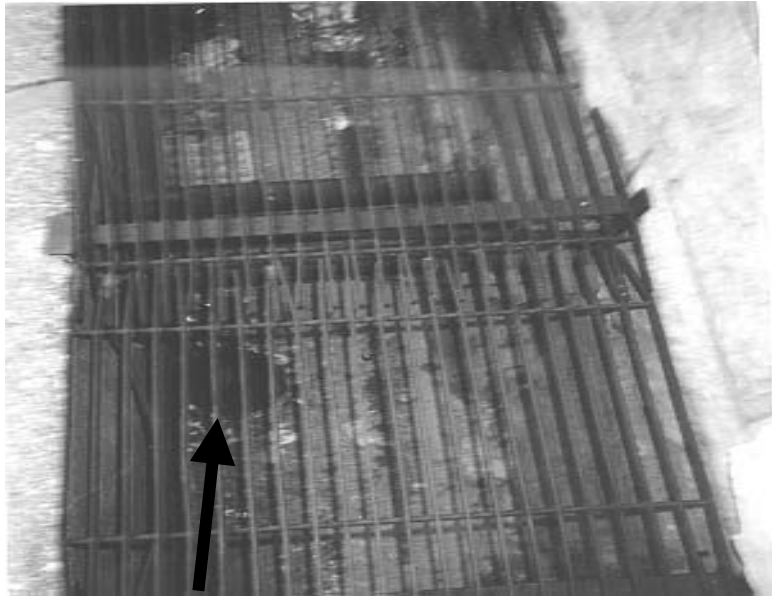
Picture 10

Pit at the Base of the South Wing

Note Debris Clogging Drain

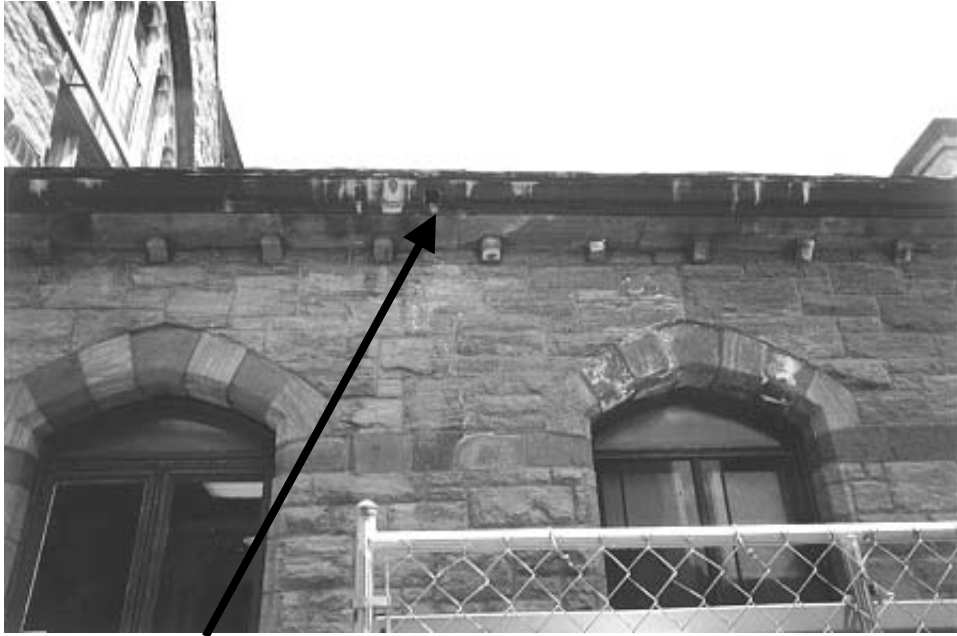
Picture 11

Roof of the South Wing of the Court House, Gutter Downspout Opening

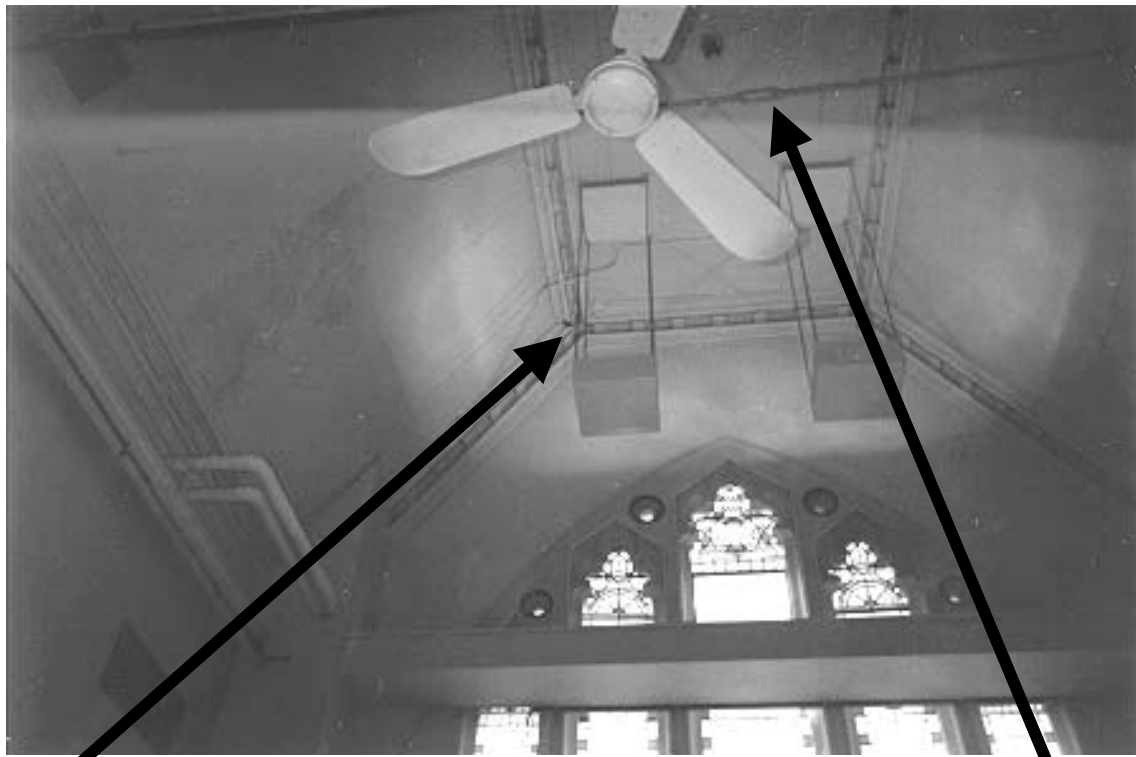
Picture 12

The registrar of deeds office has a hole in the vaulted ceiling which reportedly leaks water during rainstorms (see Picture 12). Water leakage in the ceiling near an exterior wall can be an indication of damaged slate shingles or roof flashing. Water-damaged wall and ceiling plaster can provide a source of mold growth, especially if it becomes wet repeatedly. Water damaged building materials should be replaced after a water leak is discovered and repaired.

**Interior View of Vaulted Ceiling in West Wing
Note Hole in Plaster with Water Damage and Tie-Back Bar**

This practice should be conducted routinely.
10. Repair water damaged ceilings, walls and wall-plaster. Examine the water-damaged area for mold growth. Disinfect areas of water leaks with an appropriate antimicrobial.
